**Progressive Collapse Resistance of Steel-Framed Structures with
Composite Floor Systems**

Thesis

The University of Texas at Austin

August 2014

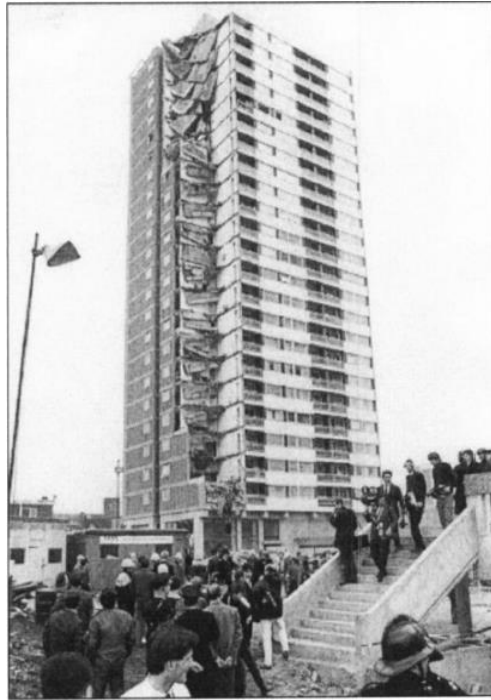
Figure 1-1: Ronan Point Apartment Tower Partial Collapse after Gas Explosion
(Pearson, 2005)

On the morning of May 16, 1968, an occupant of apartment 90 on the 18th floor lit a match for her stove, which initiated a gas explosion due to a leak. In total, four people died and seventeen were injured (Pearson, 2005). The explosion destroyed the load bearing walls in the opposite corner of the apartment. These walls served as supports to the upper floors. Therefore, after this loss, a chain reaction was triggered. Initially, floors nineteen through twenty-two collapsed one after another because they were left unsupported. The four collapsing floors fell onto floor eighteen, which could not resist the impacting kinetic energy, initiating a sequence of failures that propagated downward until it reached the ground floor. As a result, the entire southeast corner of the structure collapsed (see Fig.1-1).

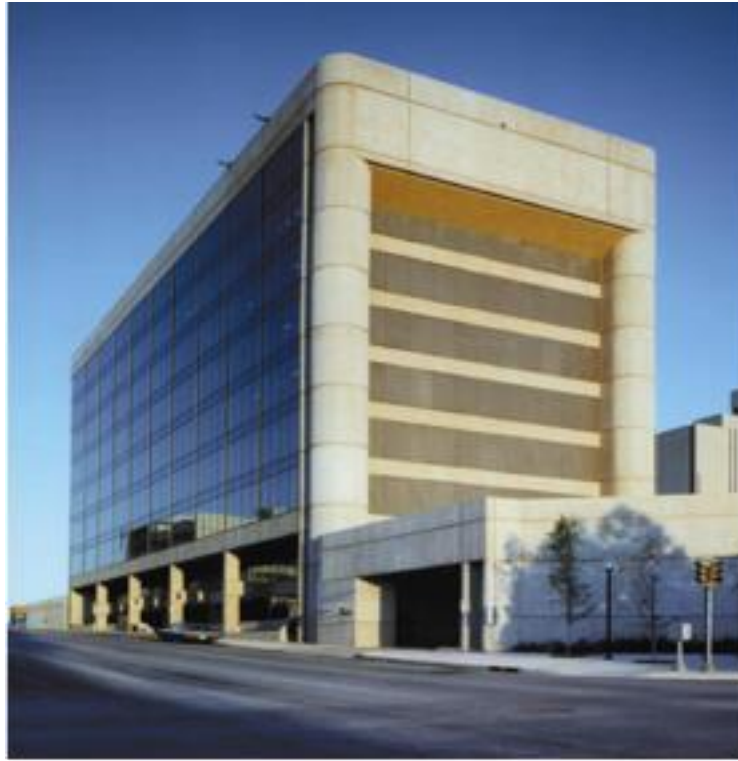
Figure 1-3: The Alfred P. Murrah Federal Building (FEMA 439A, 2005)

The truck carrying the explosive was parked in close proximity to column G20 (Figure 1-3). As a result, this column failed by brisance (i.e., shattering) (Corley, 2008). This statement is supported by the fact that no evidence of this column was found among the debris or in the crater of the explosion (FEMA 277, 1996). Loss of this column removed support for the transfer girder on the third floor between columns G16 and G24. Analysis of the structure without column G20 showed that the structure could no longer be supported by the ordinary moment frame (FEMA 277, 1996).

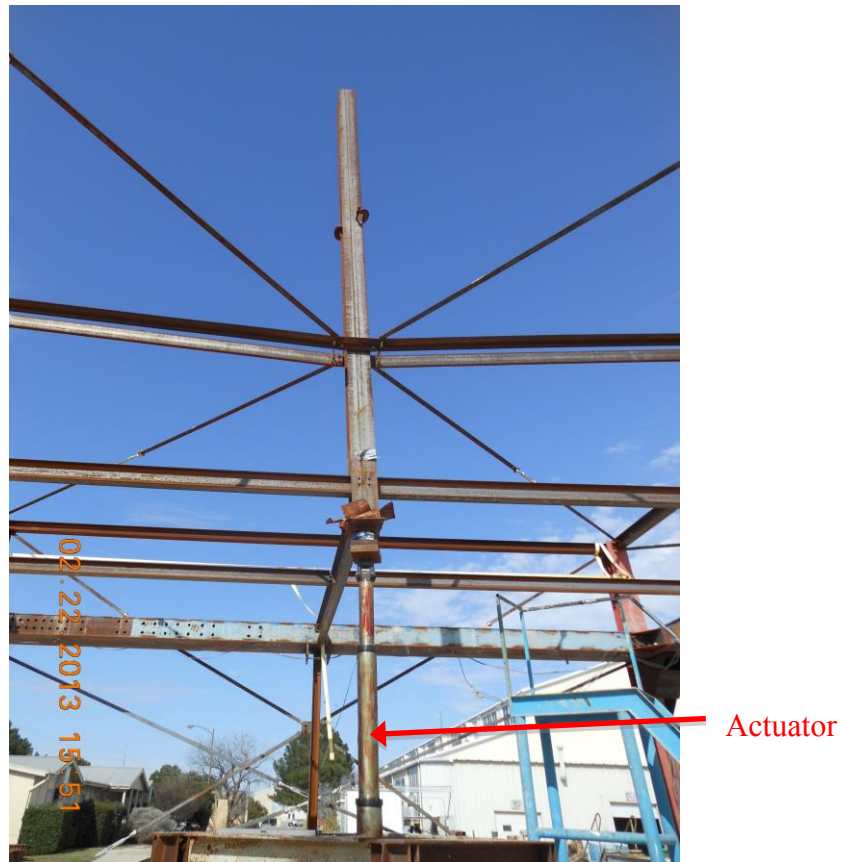
Figure 3-3: Perimeter Column, Lateral Bracing, and Actuator

A W8×31 section was used for the perimeter column. The column extended 18-feet–6-inches up from the bottom of the floor system. The perimeter column was supported by a hydraulic actuator. Details of the perimeter column and the actuator are shown in Figures 3-3 and 3-4.

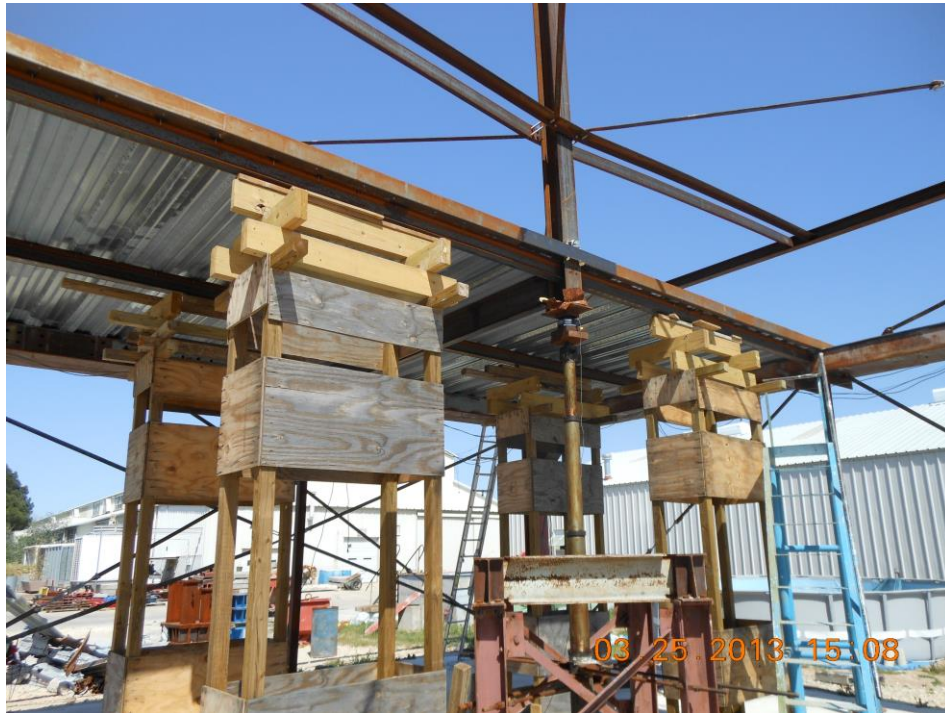
Figure 3-8: Wood Shoring During the Construction Phase

The composite floor system consisted of 22-gage steel floor decking with 2-inch deep corrugations. The concrete slab was 4.5-inches deep, measuring from the bottom of the ribs, and the specified compressive strength was 3.5 ksi. Concrete was cast on March 26, 2013. During the concrete casting and the entire construction phase, wood shoring was used for safety, as shown in Figure 3-8.

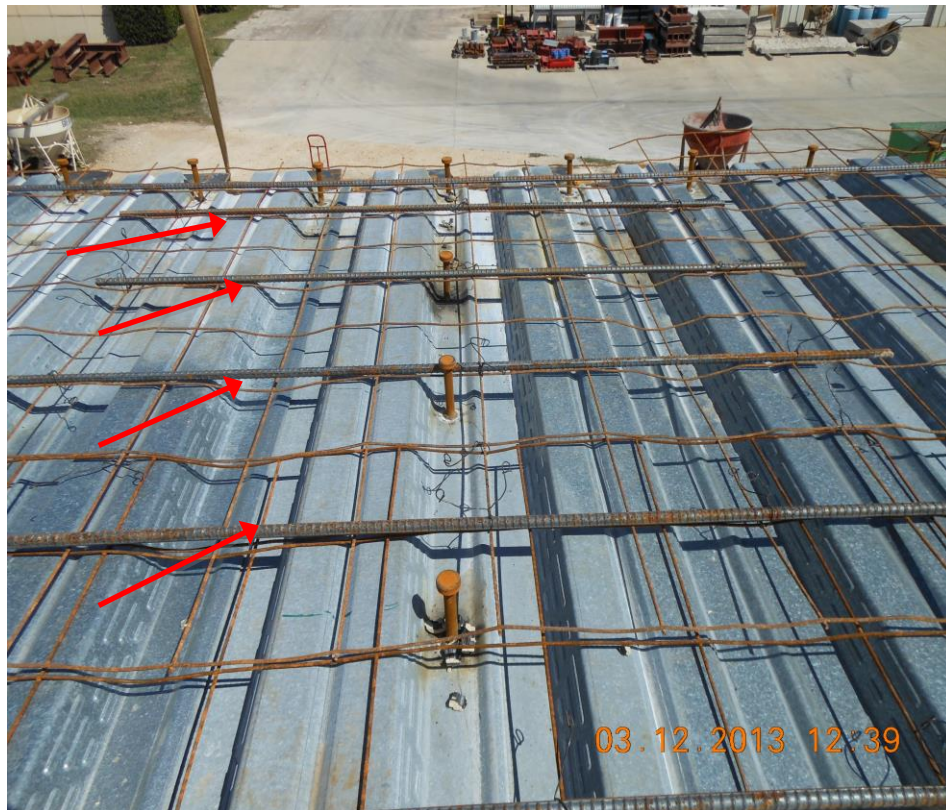
Figure 3-9: #3 Reinforcing Bars along the Girder

As far as the slab reinforcement is concerned, welded wire mesh was placed to provide resistance to cracking caused by temperature changes and shrinkage. To position the wire mesh at the desired height, chairs were used. Along the entire length of the girder, #3 reinforcing bars were placed at 12 inches, per the recommendation of Walter P. Moore (Figure 3-9). Identical reinforcement was also placed along the perimeter and at the four corners of the floor system, as shown in Figure 3-10.

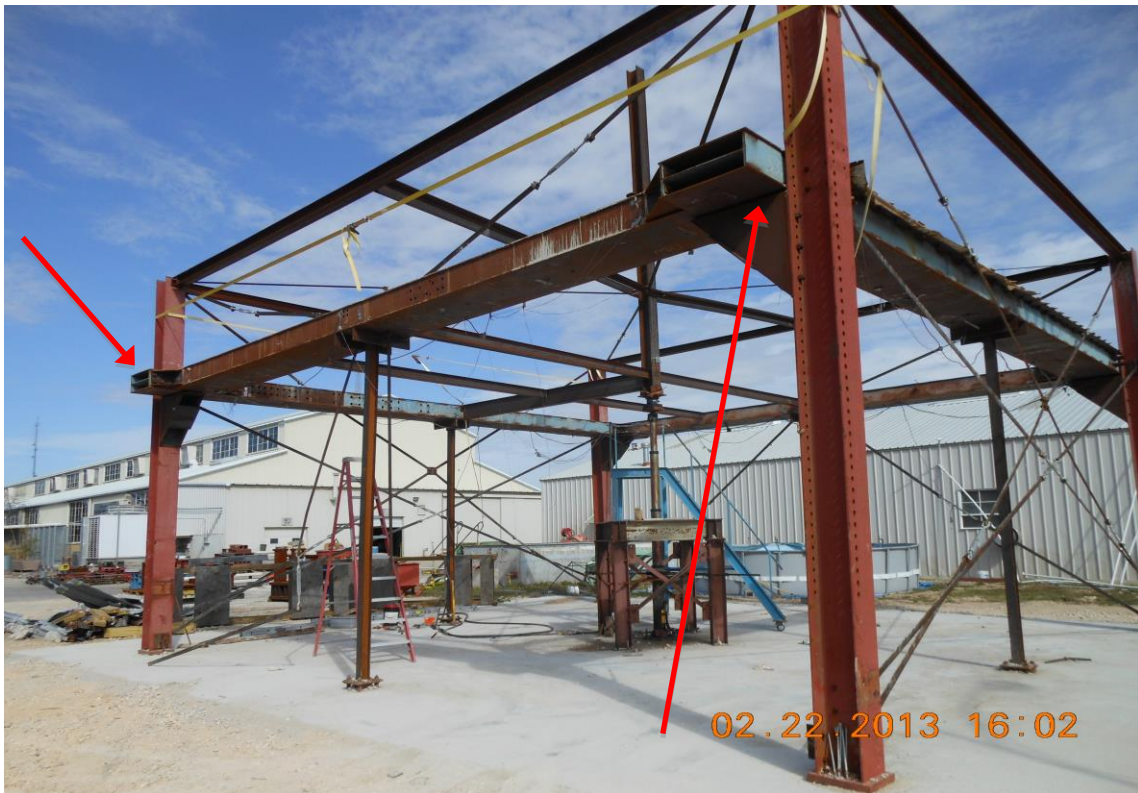
Figure 3-14: Ring Beam Corner Detail

the ring beams (Figure 3-14). It is noted that the rigidity of the north-to-south ring beams differed from the east-to-west beams due to the differences in their detailing. While the ring beam is used to simulate the continuity between adjacent bays in an actual building, it cannot capture this behavior exactly. This is due to the fact that this configuration cannot account for all the various floor systems and column removal locations. The ring beam, however, is well suited for idealized laboratory conditions and allows for a repeatable test setup. Furthermore, using the collected data to validate computational models, results from this test program can be extended to actual floor systems. Therefore, the stresses and deformations of this beam were monitored during the test so the demand that would be placed on actual floor systems could be estimated.

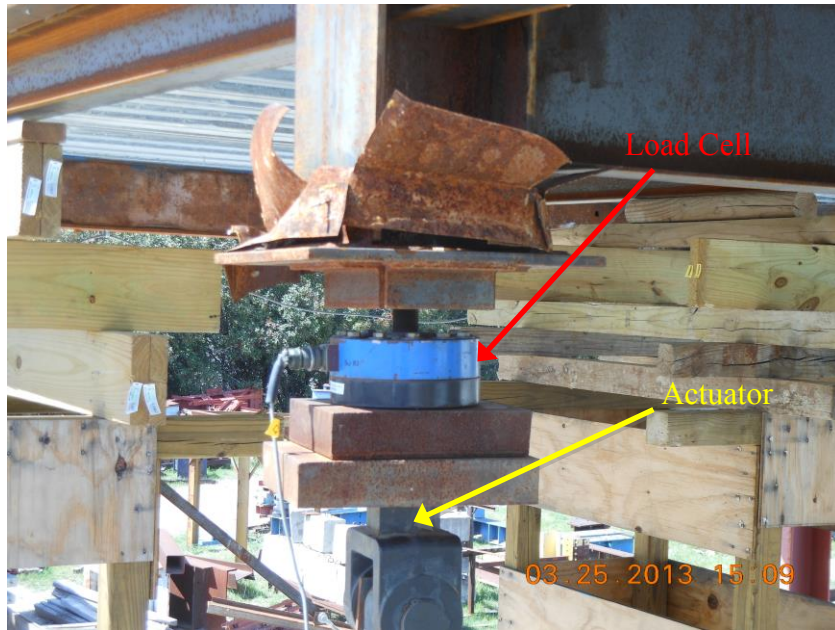
Figure 3-16: Load Cell

To measure the total load supported by the actuator, a 50-kip load cell was used (Figure 3-16). The load cell measurements were recorded from the time the test started until the point the actuator was fully disengaged from the floor slab (after that point no meaningful measurements could be extracted). To measure the additional load after column removal, flow meters were directly connected to water pumps so the total volume of water distributed to the two loading pools could be measured (Figure 3-17).

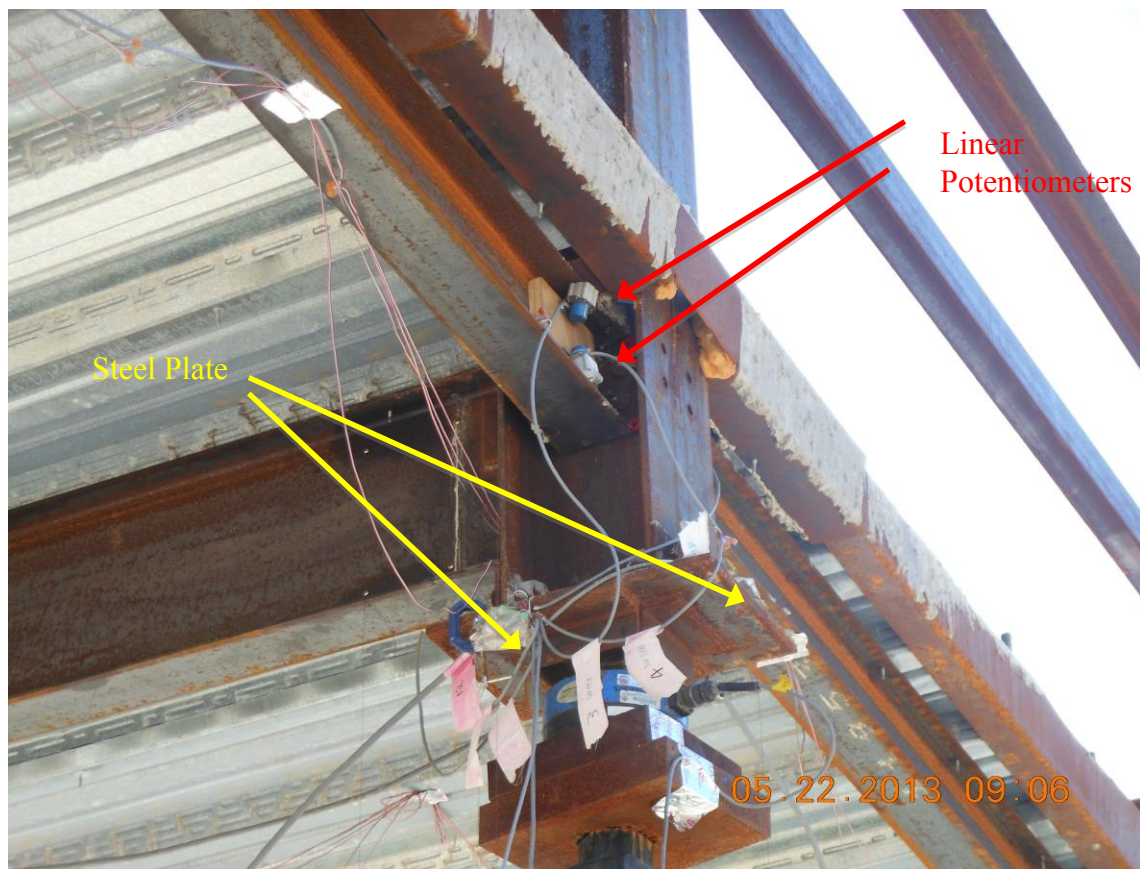
Figure 3-19: Plate Providing Clearance from Actuator and Linear Potentiometers

String potentiometers were used to measure the vertical displacement of the test specimen at eleven key locations (see Figure 3-18). Two potentiometers were placed on the north side of the actuator for redundancy in case the main potentiometer was destroyed. The capacity of the potentiometers placed on the beams and girder was 62 inches, while the capacity of the potentiometers placed around the perimeter column was 125 inches. The potentiometers rested on the concrete slab below the test specimen. The cables were fully extended and connected to the appropriate member using wire that was attached to brackets glued to the bottom of each beam. The instruments were attached at the middle of the beam bottom flanges. As far as the column is concerned, the string potentiometers were connected to steel plates that provided clearance from the actuator (Figure 3-19).

Linear potentiometers with a 7-inch stroke were used to measure the horizontal displacements. The potentiometers were attached to the top and bottom of the beam and girder webs as shown in Figures 3-19 and 3-20.

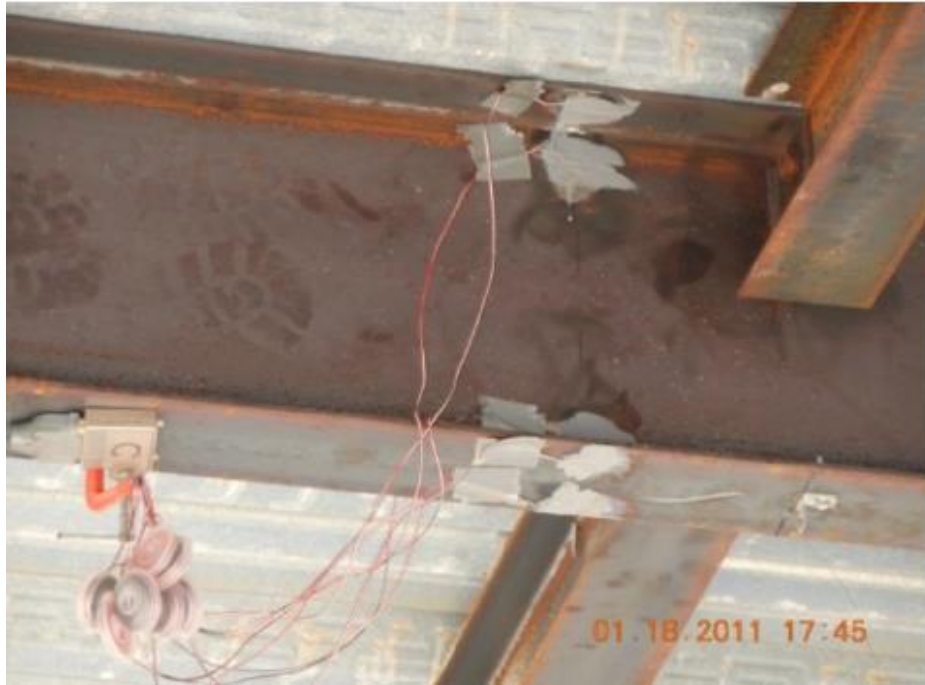
Figure 3-21: Strain Gages on Girder

To measure strains and estimate the induced bending moments, strain gages were placed on the girder, on the ring beam, and on the floor slab. The girder was instrumented with eight strain gages at midspan. The gages were offset eight inches from the beam-to-girder connection to avoid localized stress concentrations that could affect the readings. The offset was towards the north edge of the specimen. Protective coatings were used to account for outdoor exposure and to enhance the bond between the gage and the steel beam. Figure 3-21 shows the gages attached to the girder, and Figure 3-22 shows the exact location of the strain gages on the girder.

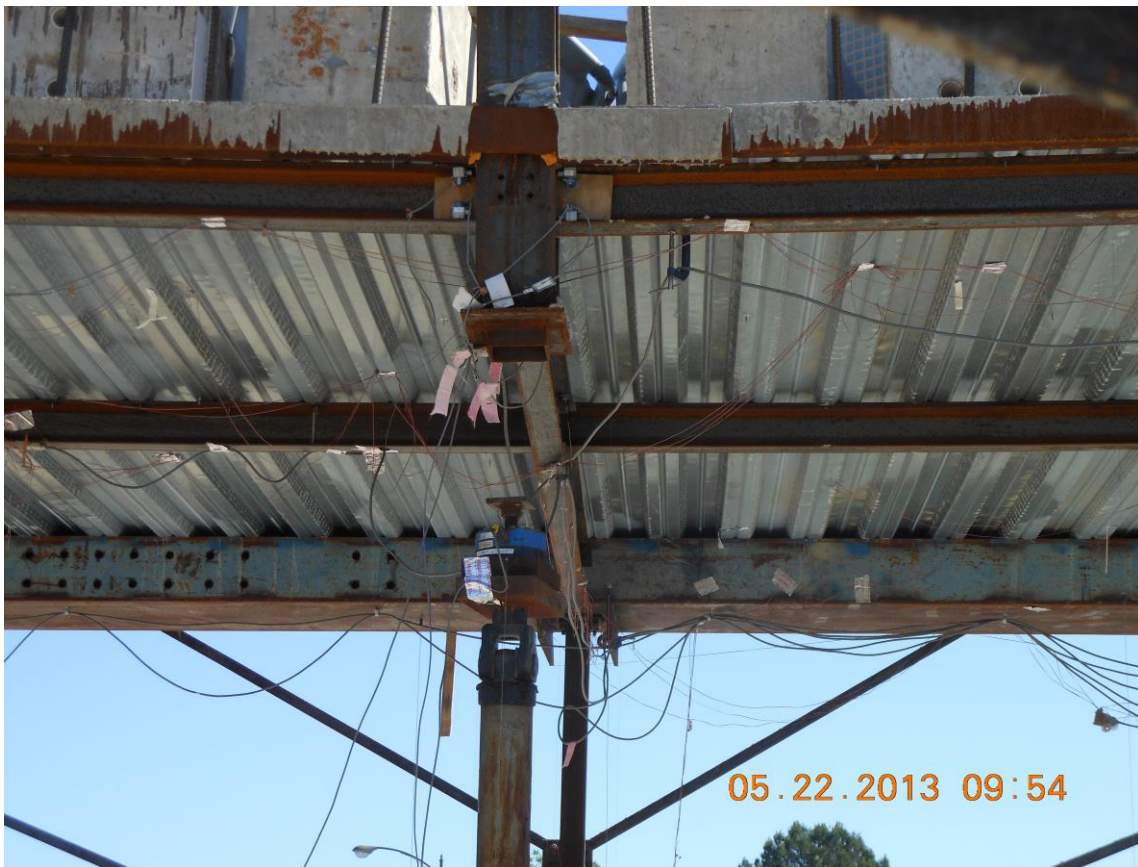
Figure 4-1: Actuator Fully Disengaged

The lowering of the actuator started at 9:12 am. The actuator was progressively lowered until it was fully disengaged from the test specimen. The actuator was lowered in increments of 0.5 inch. Between the lowering increments, the specimen was left to stabilize and come to equilibrium. The perimeter column was fully disengaged after approximately 41 minutes at 9:54 am (Figure 4-1). The deflection at that point in time was measured to be 5.03 inches. As anticipated, the specimen was able to carry the full progressive collapse design load under static conditions. At that time, the distributed load on the slab was 115 psf, and the line load acting on the edge beam was 320 plf.

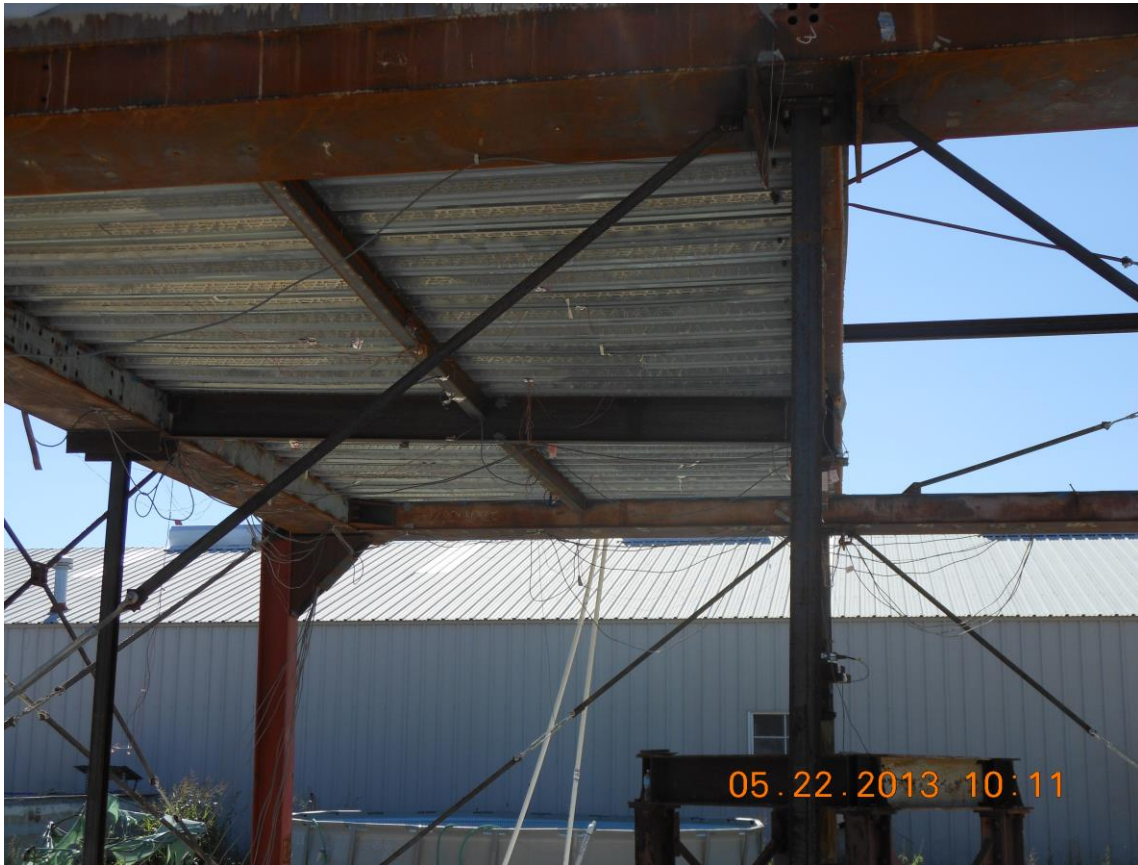
Figure 4-6: Deflected Shape when Loud Noise Occurred

curve remains fairly linear during the first 40 psf of applied superimposed load. The system starts to soften after 50 psf of superimposed load until it reaches its maximum capacity. Although the peak load and deflection just prior to the onset of collapse are known, the actual failure sequence and response of individual floor system components is not clear. Despite the large amount of data collected and visual observations made during the test, the specific mechanisms controlling the reduction in stiffness and eventual collapse are not precisely known. The test specimen reached its full capacity with no substantial damage or localized failure of any of the monitored components. Taking into account the loud noises that became louder as the load increased, it is speculated that cracking of the concrete slab was the main factor that reduced the test specimen's total stiffness. This hypothesis is further supported by the specimen's deformed shape prior to collapse, where a large deflection occurred at the position of the perimeter column (Figure 4-6). Even though concrete cracking cannot be verified by the pictures or videos of the collapse, it is assumed to have occurred.

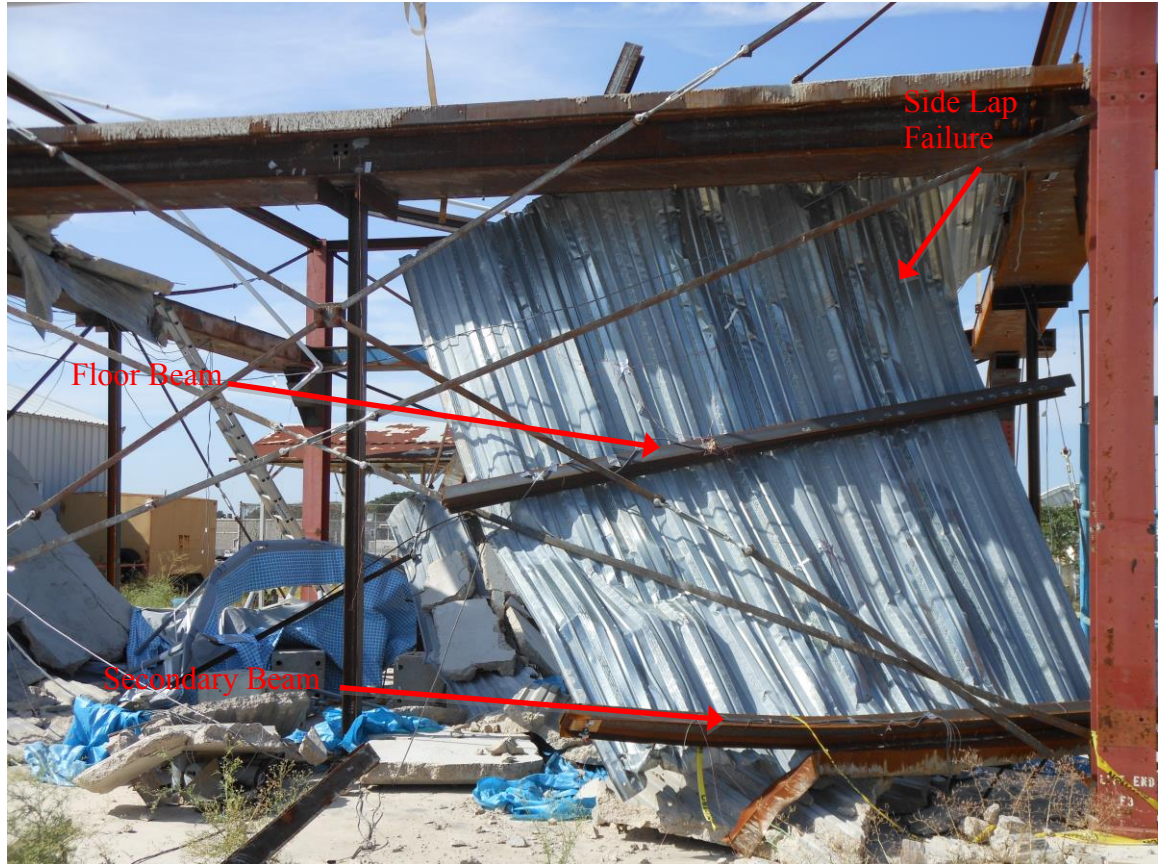
Figure 4-20: Corrugated Decking and Beams after Collapse

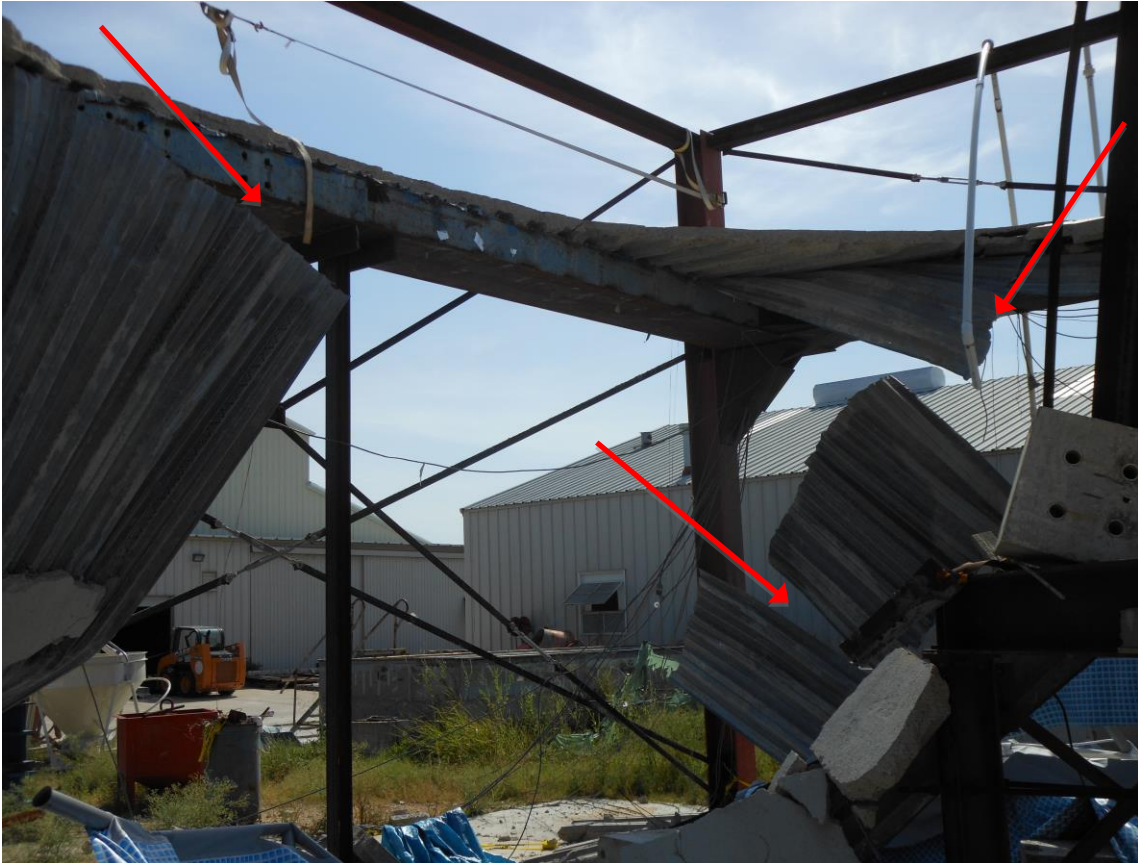
seams. It is unlikely, however, that collapse initiated due to side lap failure. Rather, this was an outcome of the collapse.

Figure 4-21: Corrugated Decking after Collapse

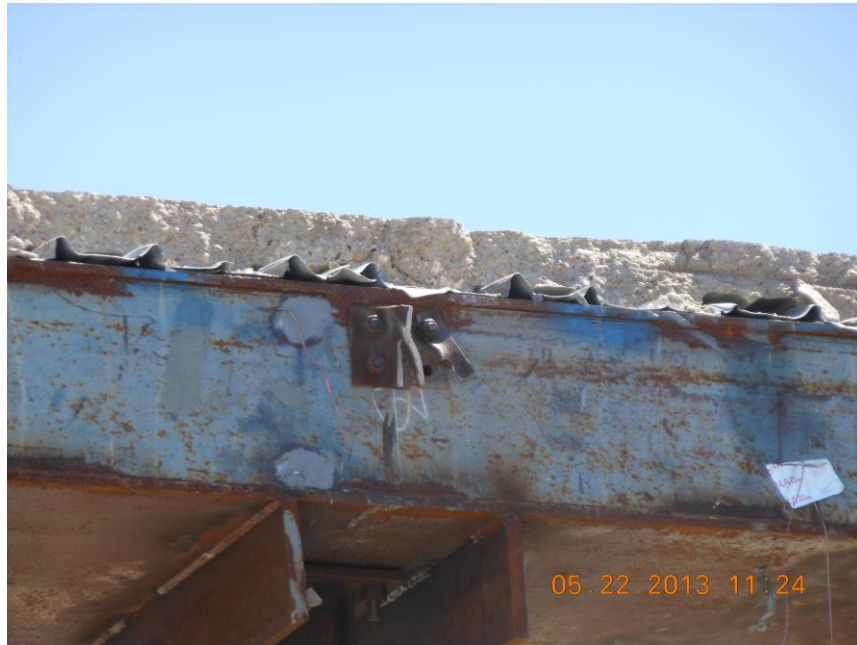
Figure 4-22: Girder-Restraining Beam Connection Failure

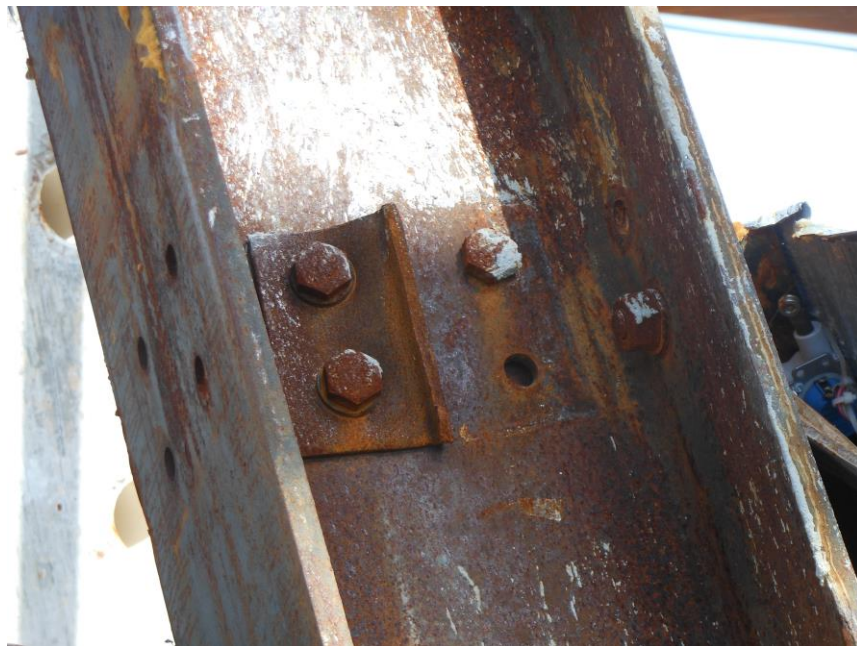
Figure 4-23: Perimeter Column-Perimeter Beam Connection Failure

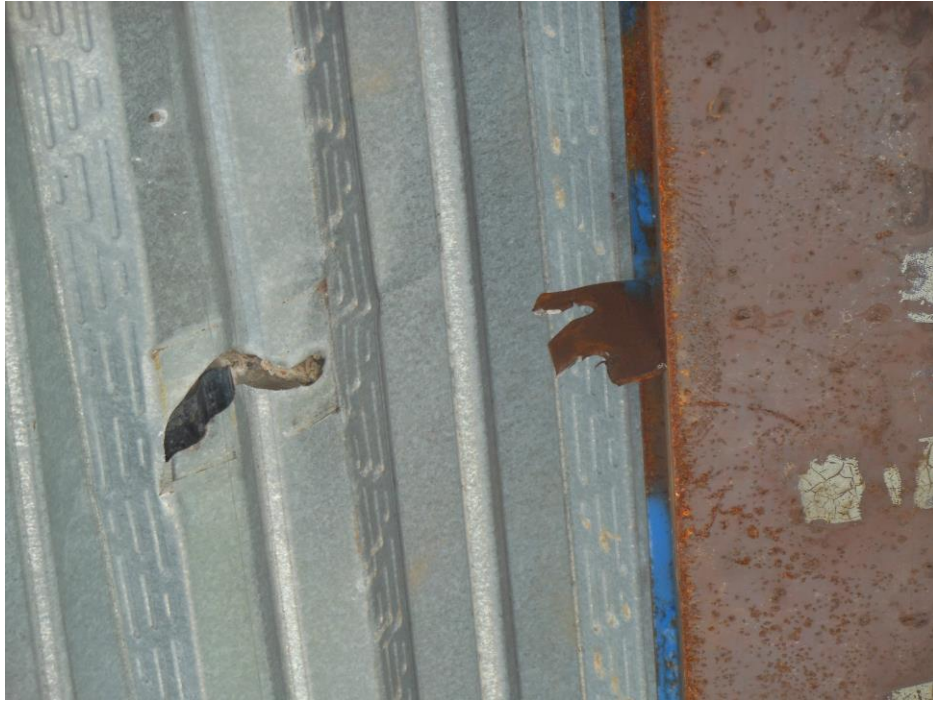
Figure 4-24: Restraining Beam-Floor Beam Connection Failure

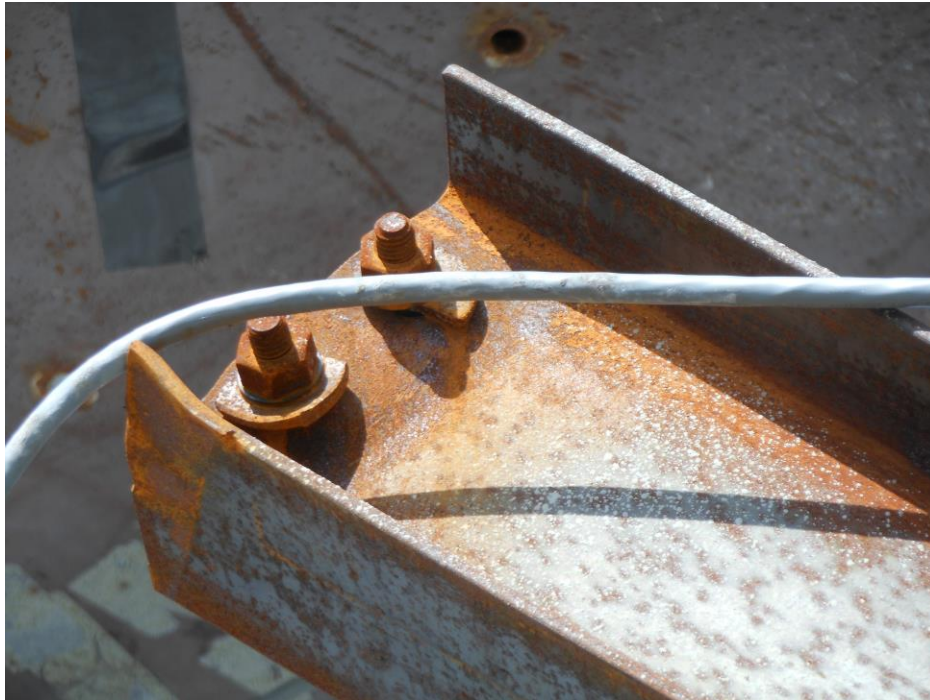
Figure 4-25: Floor Beam Connection Failure

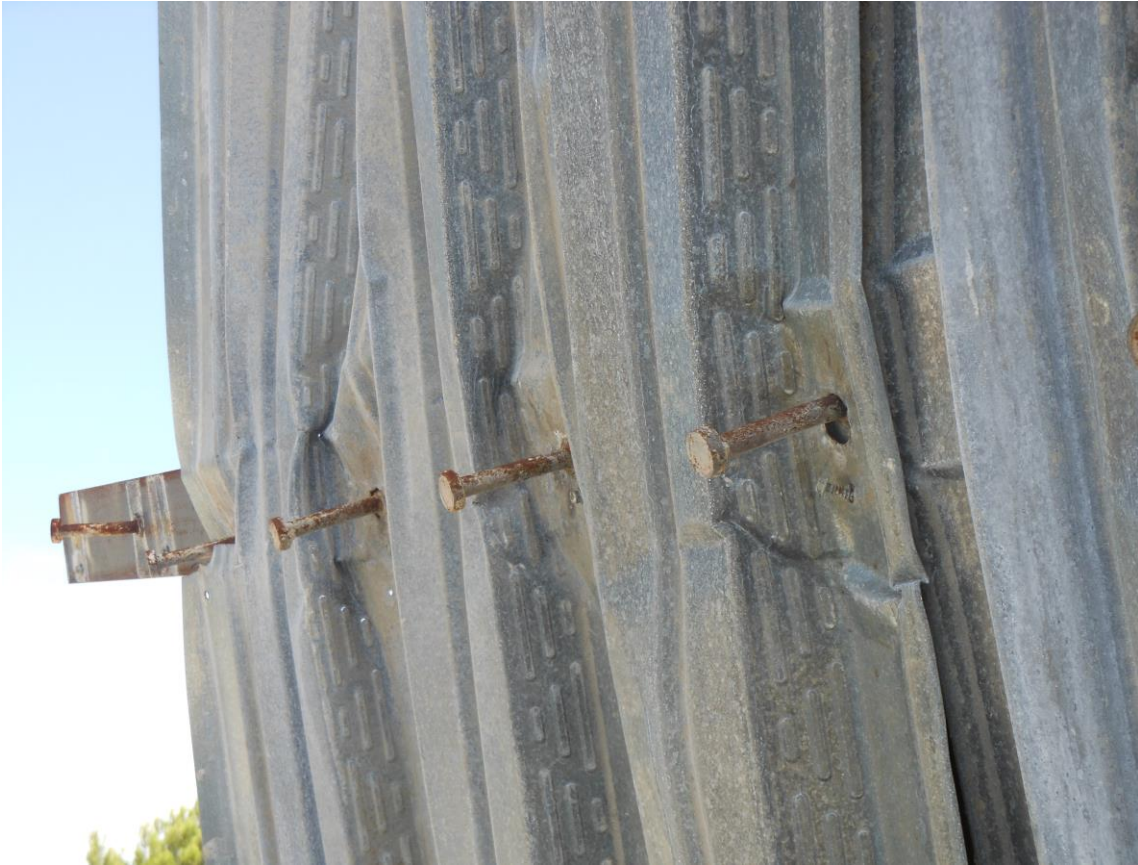
Figure 4-26: Shear Studs Remaining Attached on the Corrugated Decking

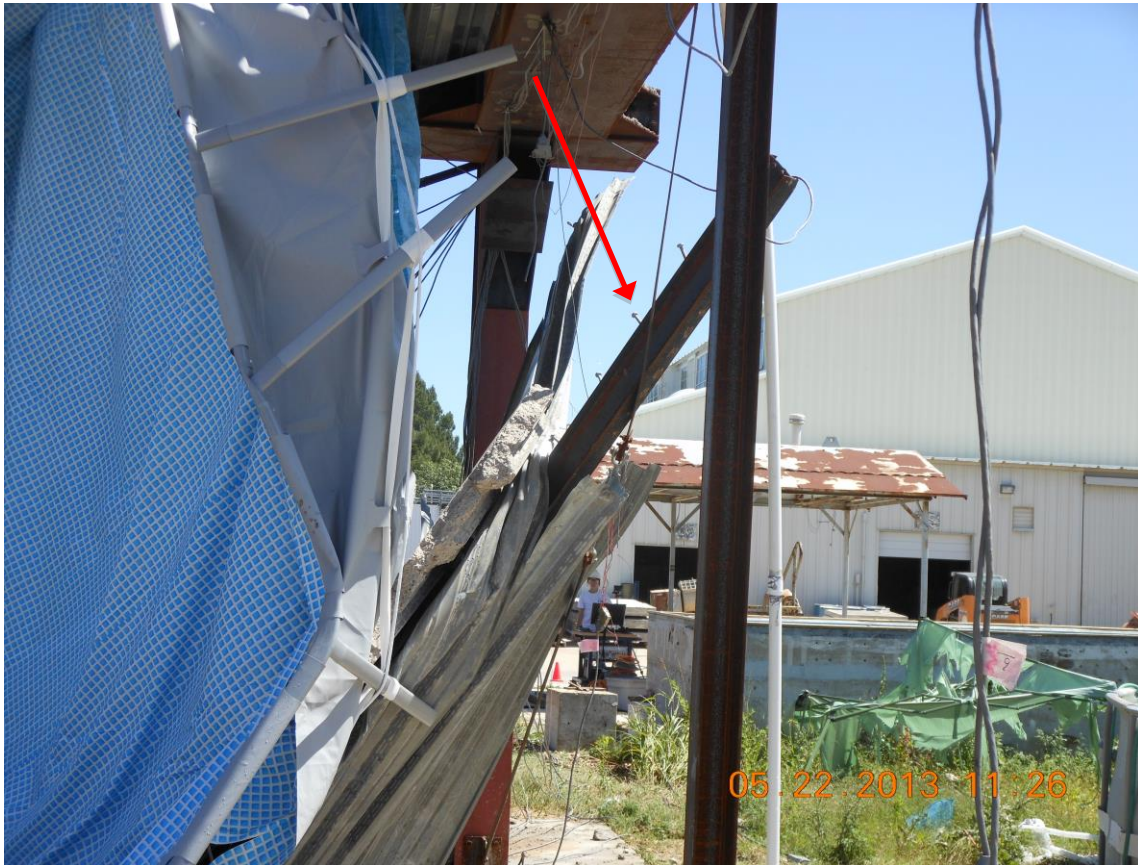
Figure 4-27: Shear Studs Tearing Out from the Corrugated Decking
